Energy efficiency in Scottish Housing Association refurbishment projects

Scottish Homes
THE NATIONAL HOUSING AGENCY

ENERGY EFFICIENCY

BEST PRACTICE
PROGRAMME

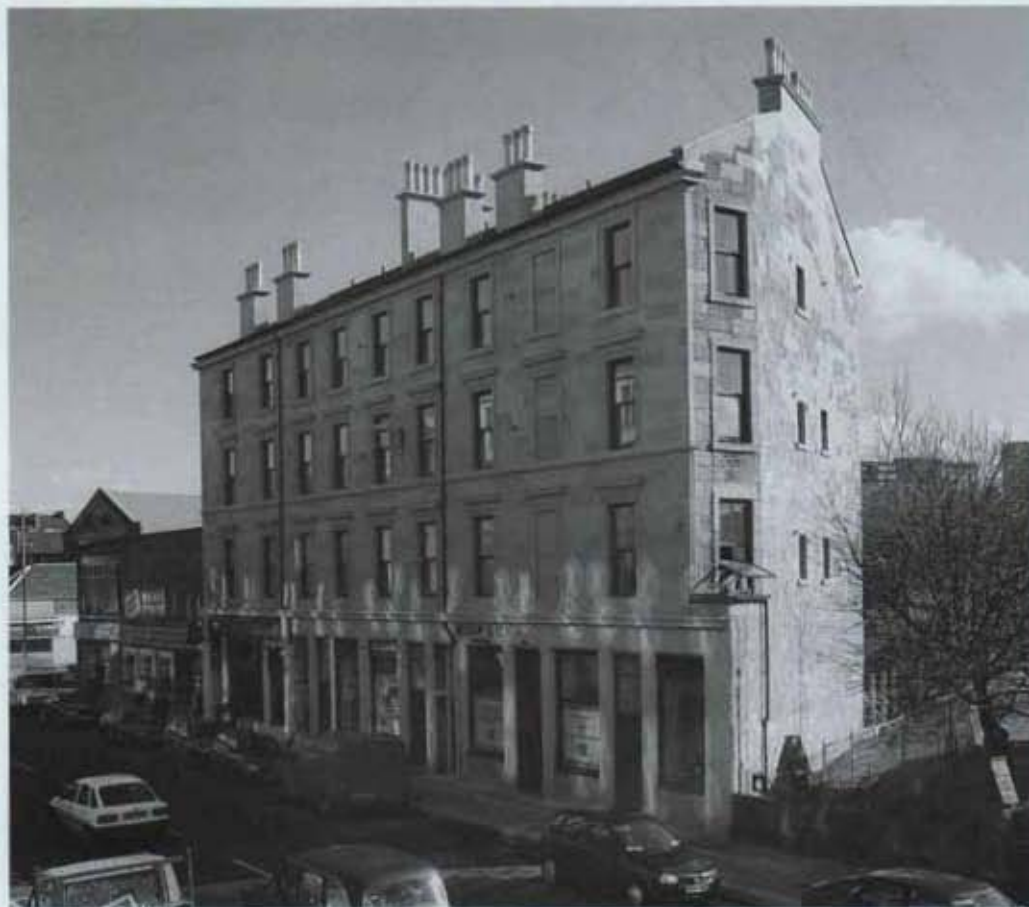
DUMBARTON ROAD, GLASGOW PARTICK HOUSING ASSOCIATION

The block has solid sandstone external walls, a pitched roof and timber/floating floor construction. Heating was by electric and coal fires.

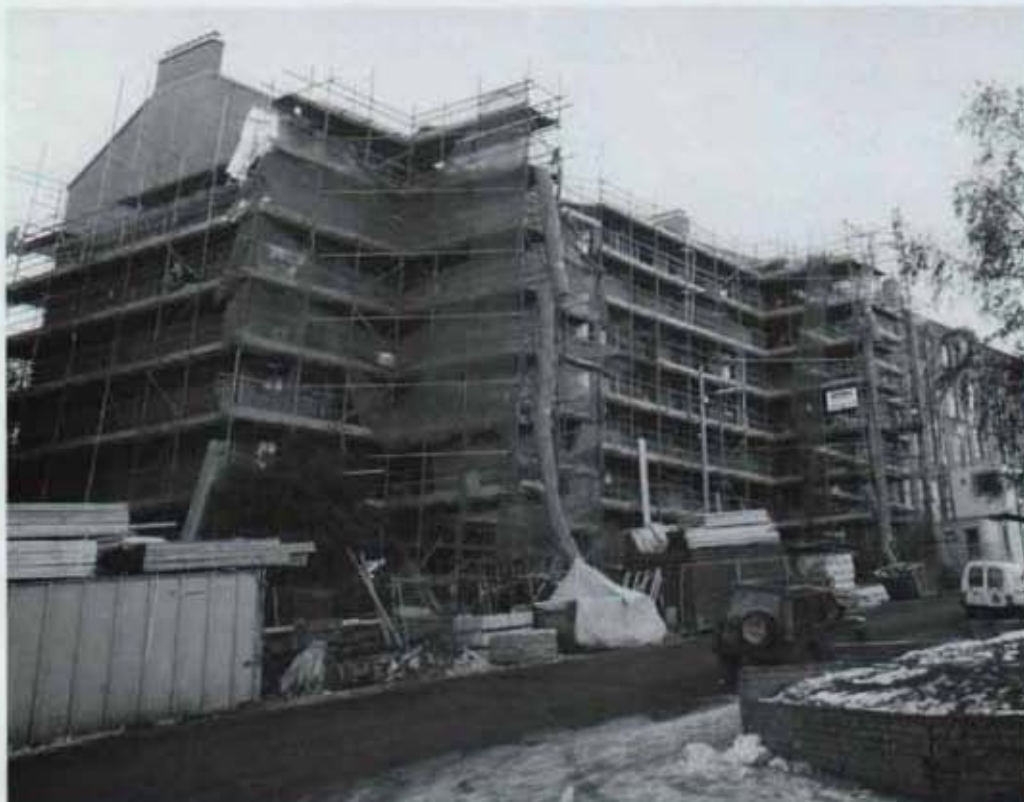
BELVILLE STREET AND BAWHIRLEY ROAD, GREENOCK CLOCH HOUSING ASSOCIATION

External walls are solid sandstone and the ground floor is of solid construction. Heating was by gas and electric fires.

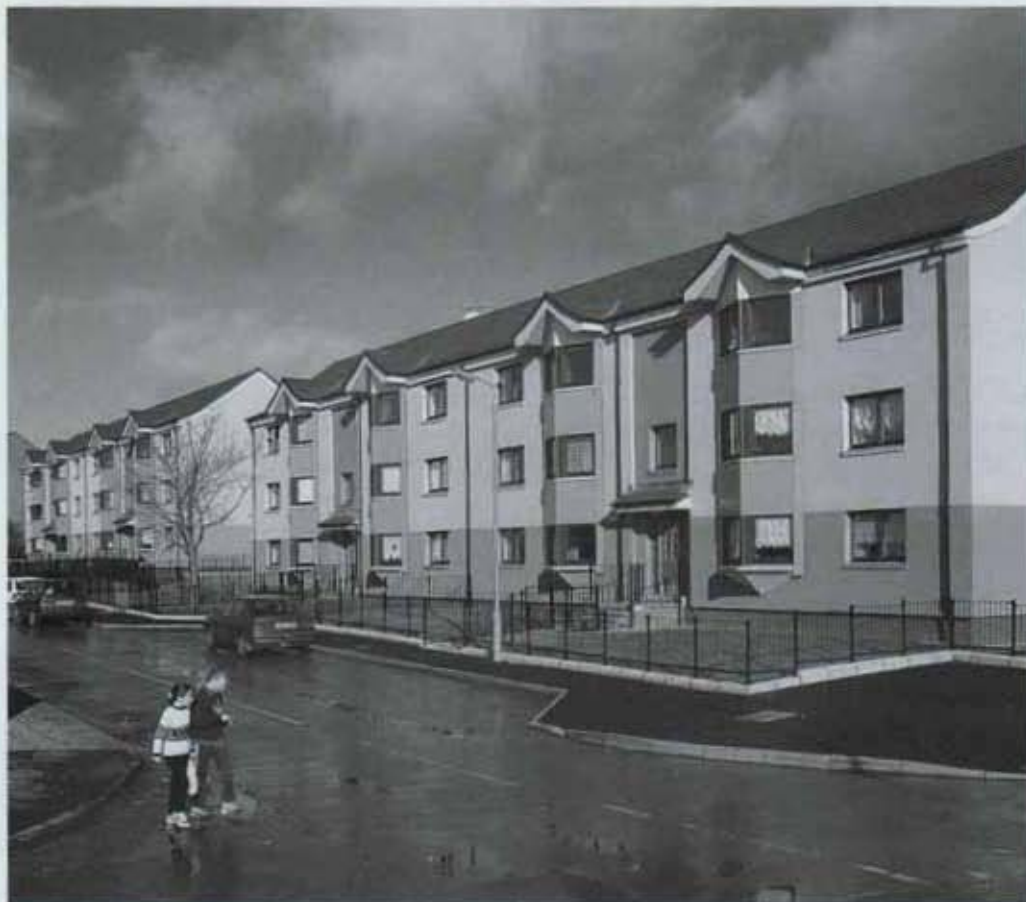
MERKINS AVENUE, DUMBARTON BELLSMYRE HOUSING ASSOCIATION

The construction comprises external walls of no-fines concrete, pitched roofs and solid concrete floors. Heating was by electric fires.

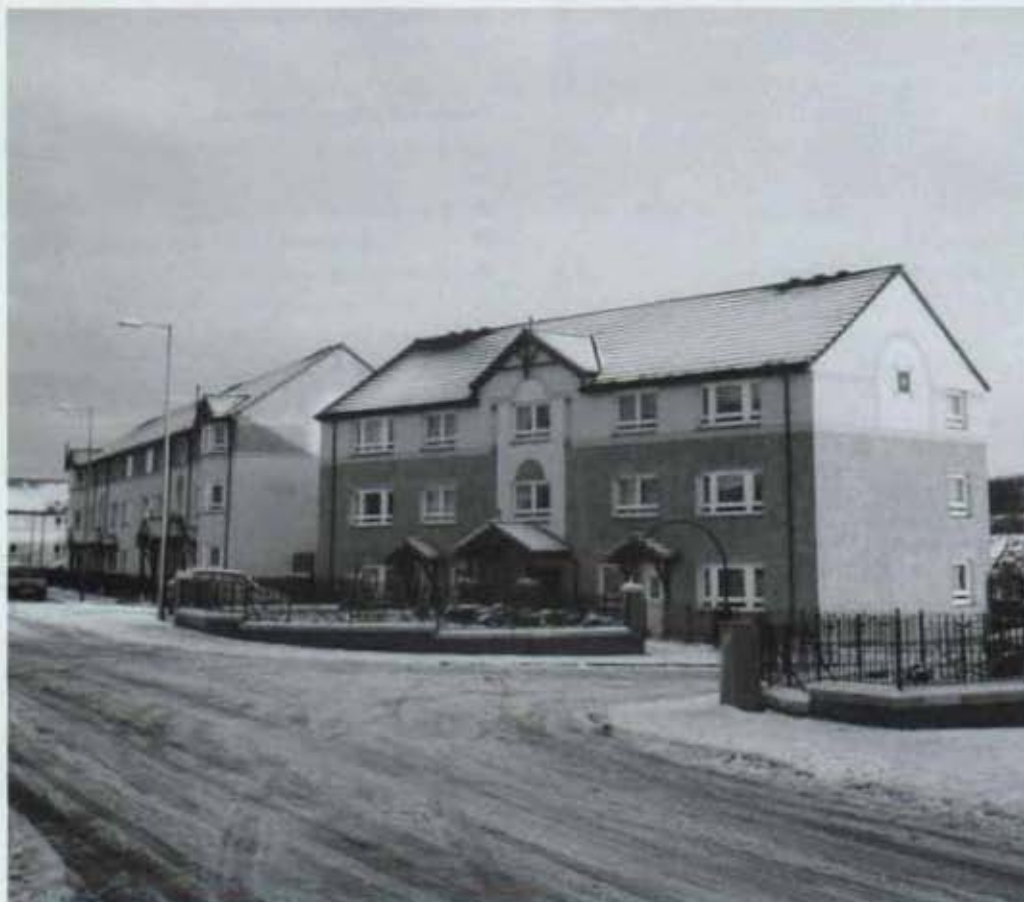
FIFE DRIVE, MOTHERWELL FORGEWOOD HOUSING CO-OPERATIVE

The construction comprises no-fines concrete external walls, pitched roofs and concrete floors. Heating was by gas and coal fires.

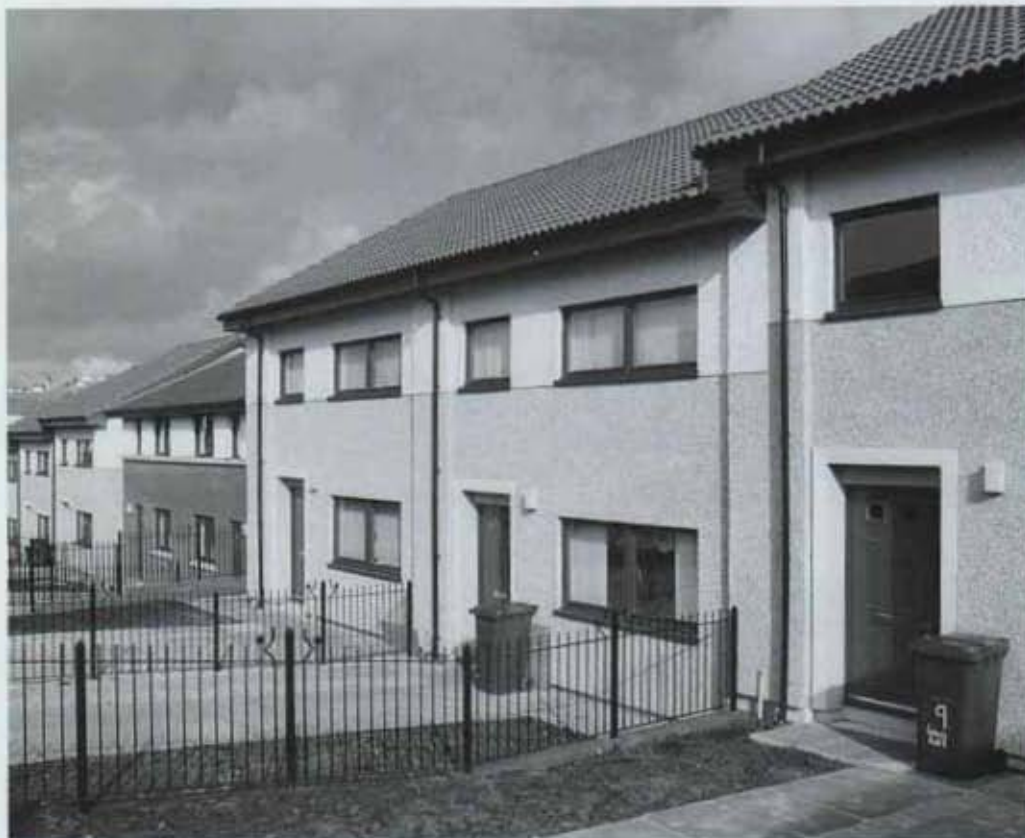
MULL AND IONA PHASE 1, AIRDRIE GAP HOUSING ASSOCIATION

The houses were built with a cross wall type construction. The single aspect terraces (ie windows on one elevation only) have gable, party and front walls of traditional cavity construction; rear walls have timber infill panels and glazed areas. The dual aspect housing is similar, but with a mixture of cavity wall and infill panels at the front. All the houses had flat roofs and solid concrete floors. They already had gas-fired central heating and double glazing, both installed during previous refurbishment work in 1990.

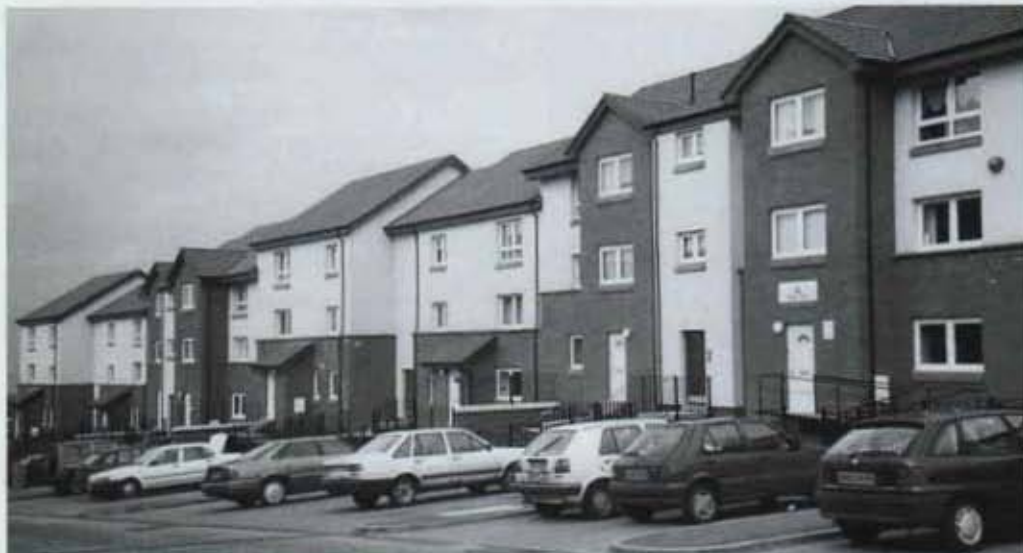
BIRGIDALE ROAD, CASTLEMILK, GLASGOW NORTH VIEW HOUSING ASSOCIATION

The construction comprises external brick-cavity-block walls, pitched roofs and timber floors. Heating was by coal and electric fires.

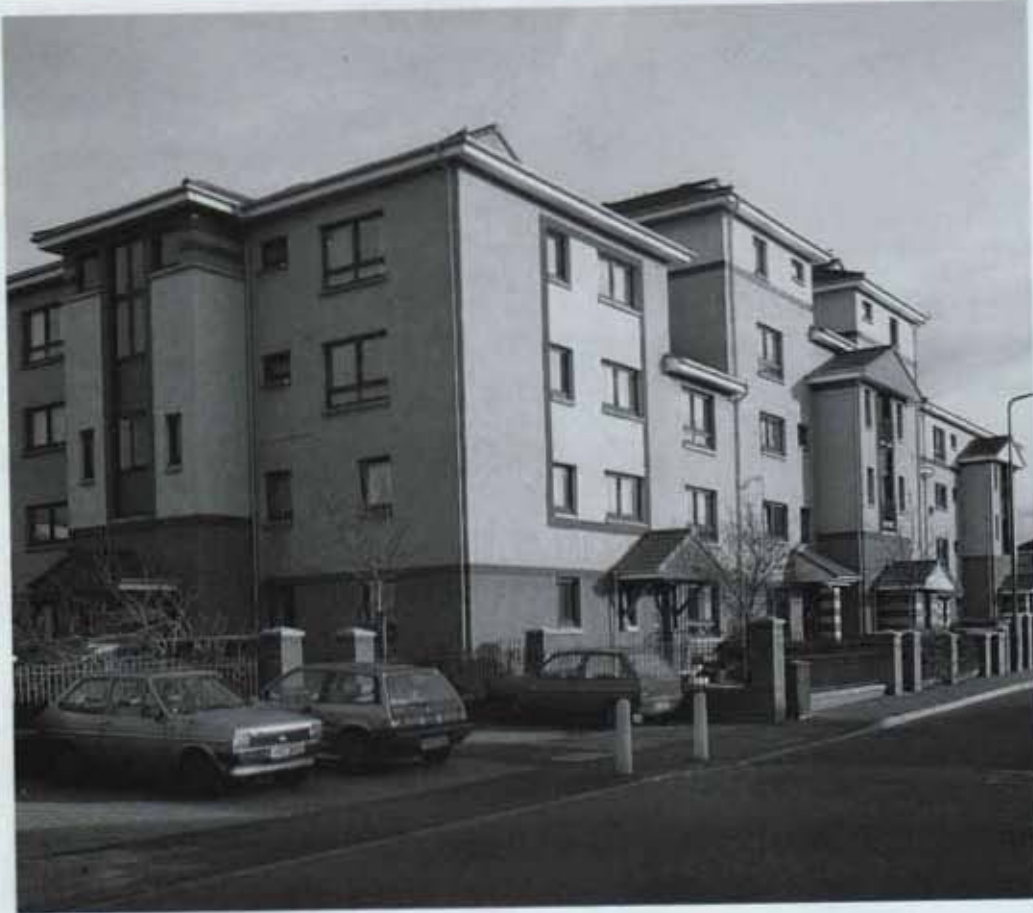
NIDDRIE HOUSE, EDINBURGH HUNTERS HALL HOUSING CO-OPERATIVE

The construction is external brick-filled cavity-block walls, concrete floors and mono-pitched roof. Heating was by a warm air system.

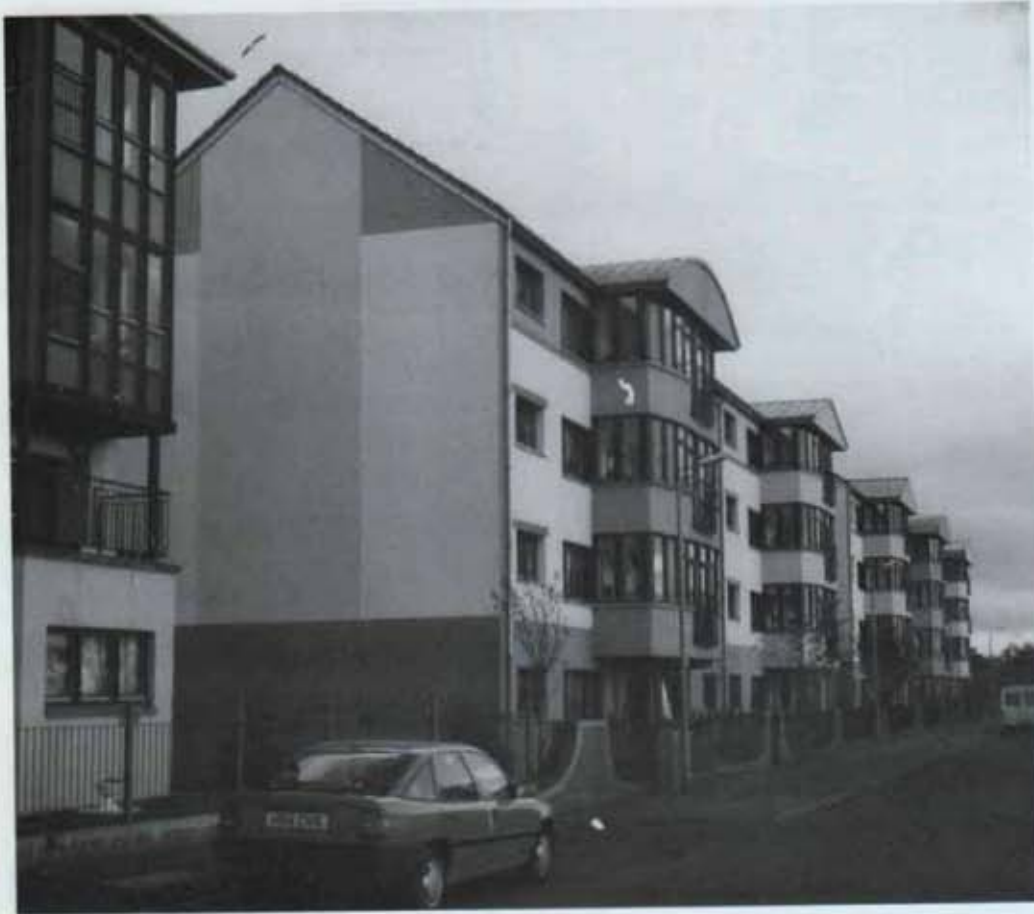
JAMES NISBET STREET, GLASGOW JAMES NISBET HOUSING CO-OPERATIVE

The construction has external brick-cavity-brick walls, concrete 'beam and block' floors and pitched roofs. Under-floor electric heating was in use.

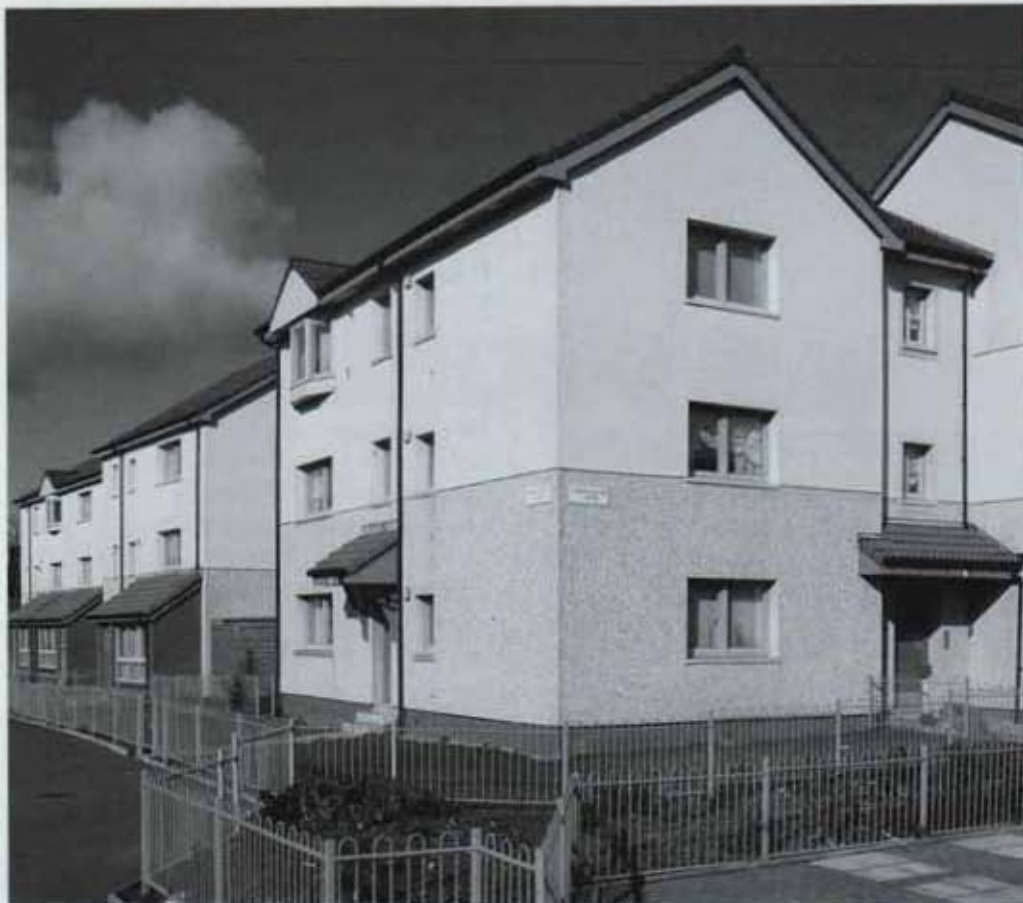
ABERDALGIE ROAD, GLASGOW BLAIRTUMMOCK HOUSING ASSOCIATION

The construction comprises external walls of brick-cavity-brick construction with timber floors and pitched roofs. Heating was by gas and electric fires.

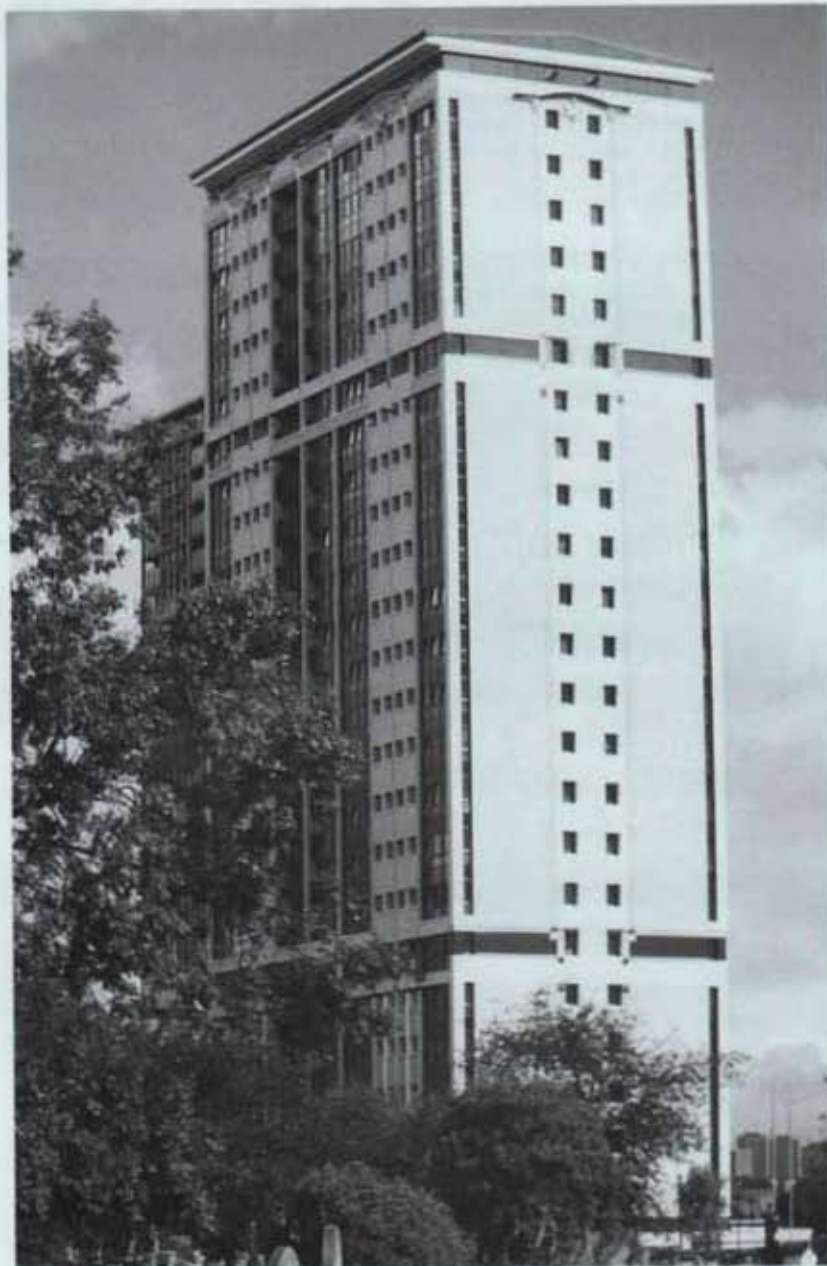
CALEDONIA ROAD, HUTCHESONTOWN, GLASGOW SCOTTISH HOMES

The block has an *in situ* concrete frame with the external walls being constructed of precast concrete cladding panels and an inner blockwork leaf. Infill areas are blockwork cavity walling, rendered externally. The flat asphalt roof was constructed on an *in situ* concrete deck and was internally insulated during earlier refurbishment work.
